## MAXIMUS™ OVERFILL DIAGNOSTIC SYSTEM FOR LP GAS TANKS

Jared Meyer<sup>1</sup>

<sup>1</sup>*Adept Science & Technologies LLC, 51 Rover Blvd. Los Alamos, NM 87544, USA*

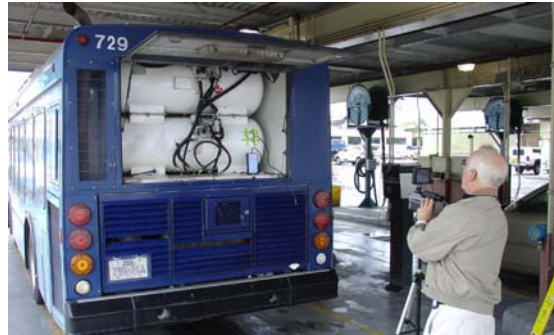
The Maximus™ dual channel system tests were successful. VIA's bus #729 was set aside for extensive testing. All modes of instrument operation were tested by moving the two transducers subassemblies above and below the liquid level. The Maximus™ instrument functionality was verified by infrared camera photos showing that the ASCENT transducers were straddling the liquid level (Fig. 3 and 4). To create a temperature differential for the infrared camera to work, a small amount of LP Gas was vented to cool the liquid portion of the tank.

Fig. 3. Setting up Infrared Camera at VIA

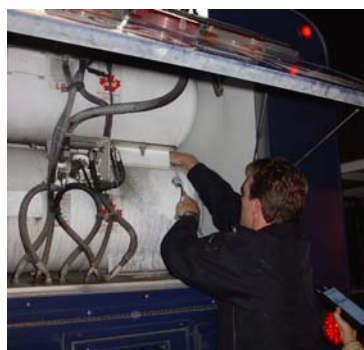
Fig. 5. Measuring the Maximus™ Detected Liquid Level after Refueling

Subsequently, data was collected from six buses during VIA's nightly fast-fill operation (Table 1). The tanks were tested with the Maximus™ instrument when the OPD stopped the flow during refueling. The arc length was measured (using a tailor's measuring tape) from the top weld of the tank to the point on the side of the tank where the Maximus™ instrument detected the LP Gas liquid level (Fig. 5). A single channel Maximus™ unit was used to non-invasively detect the liquid level by moving the magnetized sensor head assembly up and down the surface of the tank shell along the vertical axis.
